**RESTORATION TECHNIQUES FOR COASTAL DUNES AND RESTINGAS
DEGRADED BY PINUS ELLIOTTII ENG., IN SOUTHERN BRAZIL****TÉCNICAS DE RESTAURAÇÃO DE DUNAS COSTEIRAS E RESTINGAS
DEGRADADAS POR PINUS ELLIOTTII ENG., NO SUL DO BRASIL****TÉCNICAS DE RESTAURACIÓN DE DUNAS COSTERAS Y RESTINGAS
DEGRADADAS POR PINUS ELLIOTTII ENG., EN EL SUR DE BRASIL**

Tiago Pereira dos Santos¹, Marcelo Maisonette Duarte²**ABSTRACT**

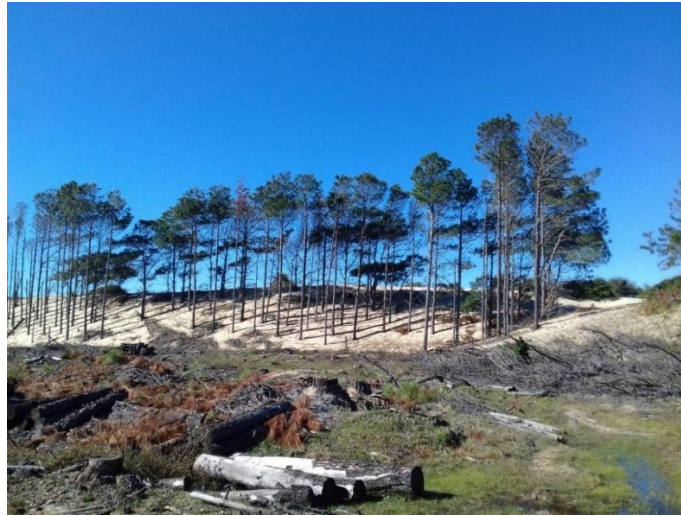
Figure 2

At the beginning of the project, the area underwent initial management activities. Due to the presence of advanced *P. elliotii* plantations in the dune system, the first action taken was the clear-cutting of adult specimens (Figure 2), thereby retreating the commercial plantation boundary from the dunes and reducing the impact on the APP's.

Pine trees (Pinus elliottii) in coastal sand dunes

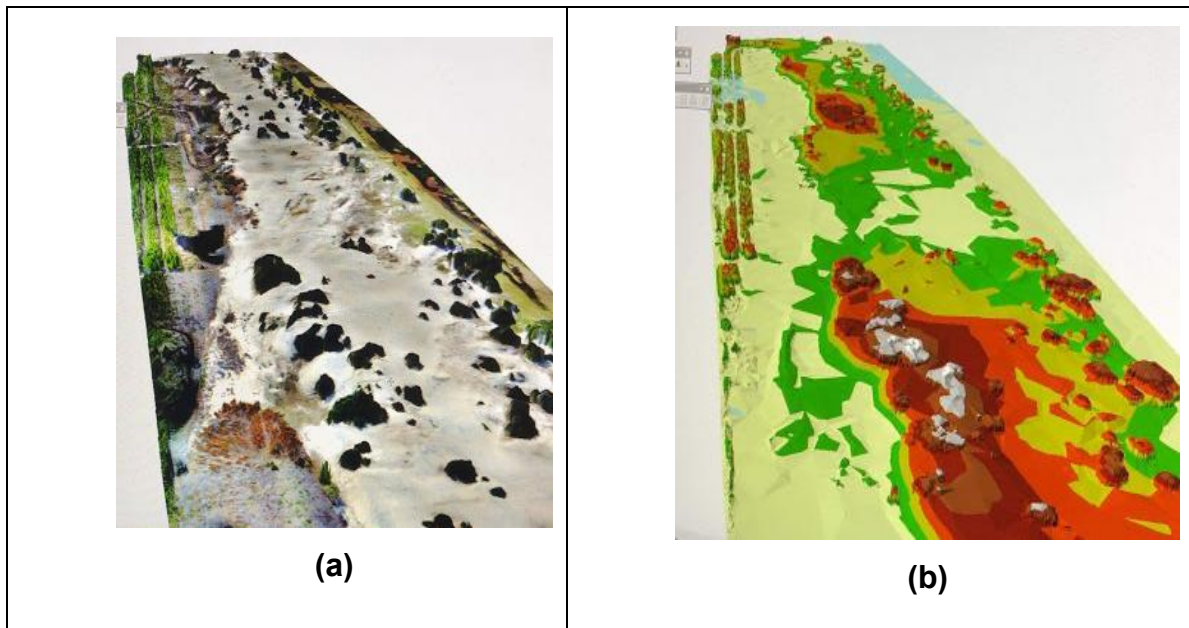
Figure 3

Aerial images captured by drone mapping and topographic contour data were used to identify suitable areas (elevated zones, lowland areas, and vegetated zones) for plot placement (Figure 3), also taking into account logistical feasibility for field installation.

Aerial images captured by drone mapping (a) and topography (b)

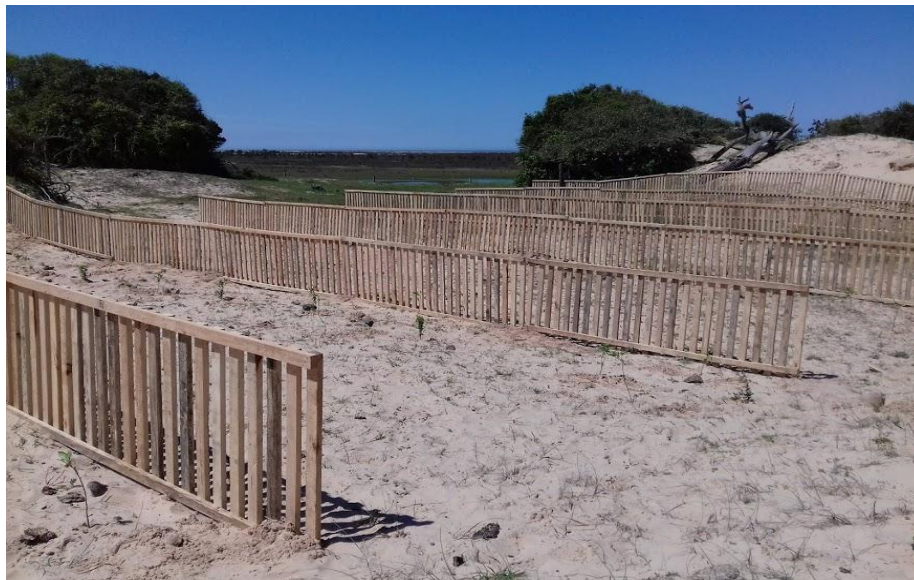
Figure 4

fences and seedling protection . This technique aimed to retain sand and protect native seedlings from strong winds. The fences also served as perching structures for migratory birds using the area as a flight path. The fences were built using *P. elliotii* wood planks and measured 1.30 meters in height (Figure 4); b) Coconut fiber biomat for sand containment and moisture retention. Made from coconut fiber, this material has a relatively short lifespan when exposed to the natural environment. The biomat has standard factory dimensions and was adapted on-site for this project. It is commonly used in bioengineering to retain sediment and moisture, facilitating seed germination and seedling development (Figure5); c) Nuclei planting of native seedlings without fencing and biomat. The same methodology as the first experiment was used, but with 3-meter spacing between nuclei. The same five species were used. All plots were marked using locally available materials, including wood residues from previous harvesting. The plots were delineated using *Pinus* stakes. In the dune crest, only one plot was installed, consisting of nuclei planting with 20 replications using both sand retention fencing and biomat.

Sand retention fences

The sand containment fences proved efficient at the dune crest by containing sand in unvegetated areas and improving seedling survival in vegetated plots, as they reduced wind impact. Accumulated sediment hindered seedling development at the crest but helped stabilize the dune and prevent encroachment into commercial planting areas.
